# Church of Divine Wisdom: Hagia Sophia

## *Kutsal Bilgelik Kilisesi: Ayasofya*

Nilay YILMAZ EMRE

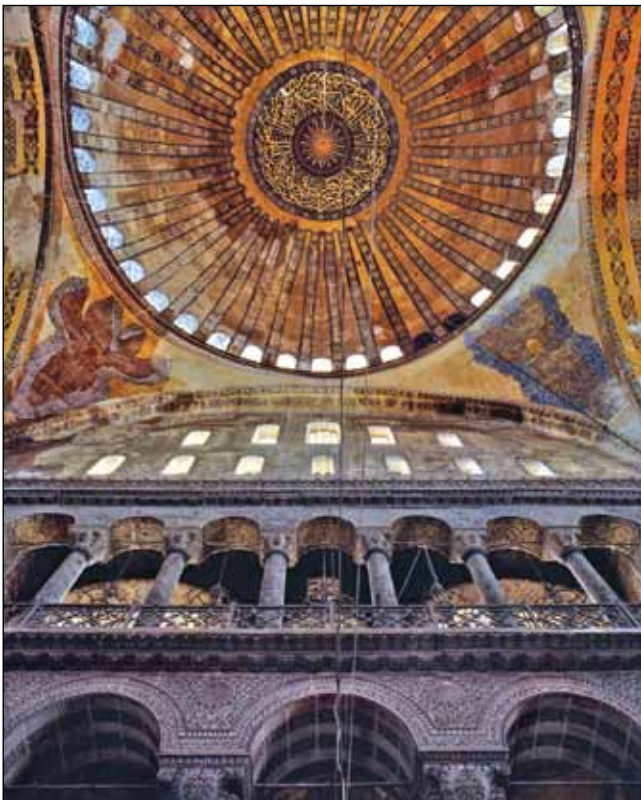
**Figure 4:** Another view of the central dome and upper gallery.

Naos, Hagia Sophia's worship area, is divided into two side naves by four large pillars and the columns between them (Figure 4, 5). This section that longitudinally clearly represents the Byzantium basilica plan has dimensions of 73.50 x 69.50 meters. The main section is on pendants carried by four large pillars and the dome that sits on the hoop is 55.60 meters

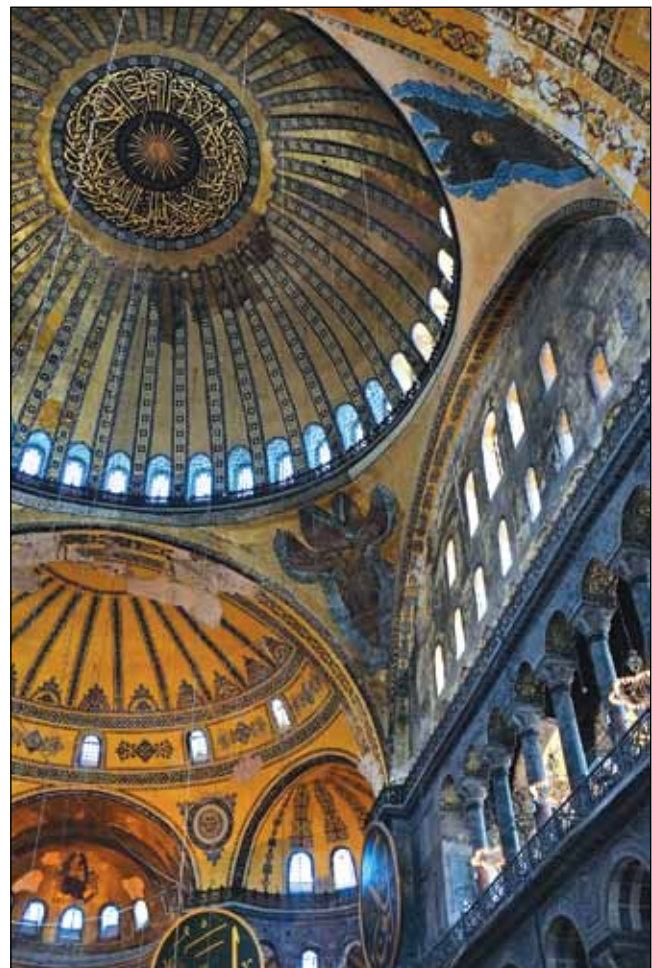
**Figure 5:** Another view of the central dome and the South tympanon wall.

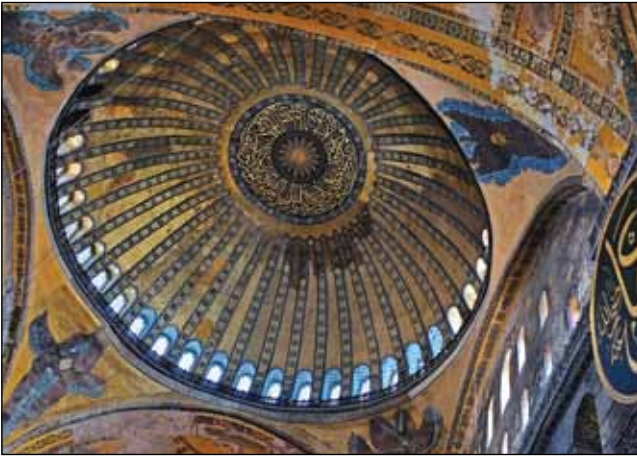
**Figure 6:** Central dome of Hagia Sophia.

high. The dome has lost its circular feature after various repairs and is now ellipsoid. The south-north diameter is 31.87 meters and the east-west diameter 30.87 meters (Figure 6). The eastern aspect of the dome was completely destroyed by an earthquake 22 years after it was built and it was repaired by Architect Isidoros' nephew with the same name. The dome's height was increased 7 m and supports that would prevent its extension were built laterally. The new dome's east-west diameter became smaller. Emperor Iustinianus opened Hagia Sophia once again on 24 December 562 together with Patrick Eulhyus. However, Hagia Sophia still did not have a structurally sound dome. The western half-dome was almost destroyed in the 869 earthquake during the Emperor Basileus I (867 - 886) period. It again suffered great damage in the 989 earthquake. During the Emperor Basileus II period (1025-1028), an Armenian architect named Trinidat repaired Hagia Sophia and covered the dome fractures. (Figure 7).

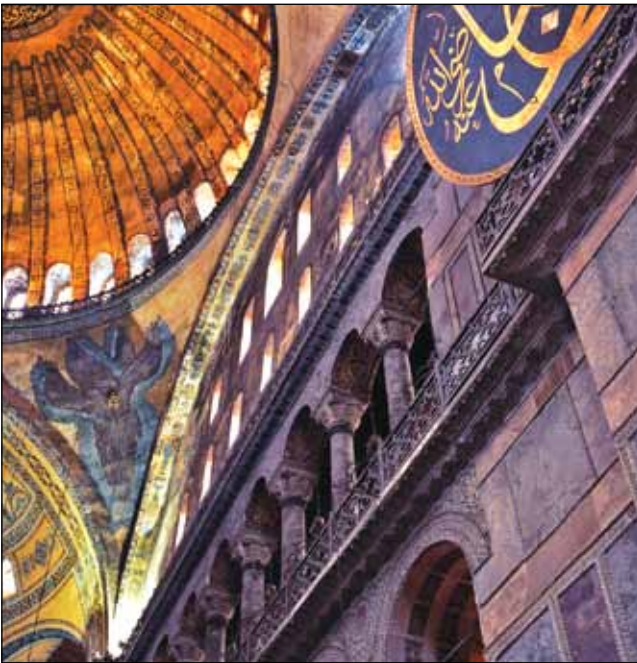
**Figure 7:** The series of columns on the South tympanon wall above.
