# Late Calcification and Rupture: A Rare Complication of Ventriculoperitoneal Shunting

Cahit KURAL<sup>1</sup>, Alparslan KIRIK<sup>1</sup>, Serhat PUSAT<sup>1</sup>, Tolga SENTURK<sup>2</sup>, Yusuf IZCI<sup>1</sup>

<sup>1</sup>*Gulhane Military Medical Academy, Department of Neurosurgery, Ankara, Turkey*

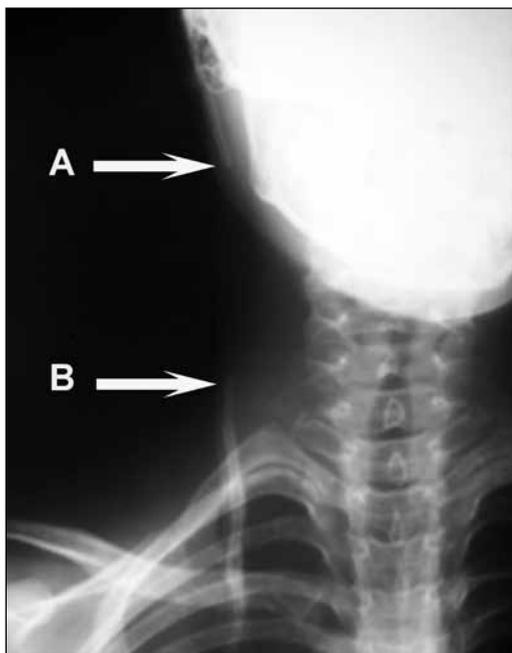
**Figure 1:** X-rays of the neck show rupture and disconnection of the ventriculoperitoneal shunt between the mastoid bone (A) and clavicle (B). Enlargement of the shunt distal tube due to calcification is also observed on the chest wall.

lateral gaze at the right eye with bilateral papilledema. The neurological examination was otherwise within normal limits. The restricted lateral gaze in the right eye was reported to develop within 6 months of the first operation. The serum and hematologic values of the patient were within normal limits and the skin at the site of shunt was not tender or inflamed. X-ray of the neck revealed the disconnection of the shunt at cervical region (Figure 1), and computed tomography (CT) scan showed dilatation of the lateral ventricles and focal calcifications (Figure 2).

The patient was operated on and the peritoneal part of shunt catheter was removed. No cerebrospinal fluid (CSF) leakage was noted through the shunt. Afterwards, with an incision at the cervical region, the disconnected sides of the catheter were found. The catheter was observed as fixed to subcutaneous tissue from cervical to abdominal region and was surrounded with a dense calcified fibrous tissue (Figure 3). The tips of the proximal and distal tubes were closed by fibrotic tissue, but the lumen of the shunt was not obstructed due to calcification. There was no CSF collection in

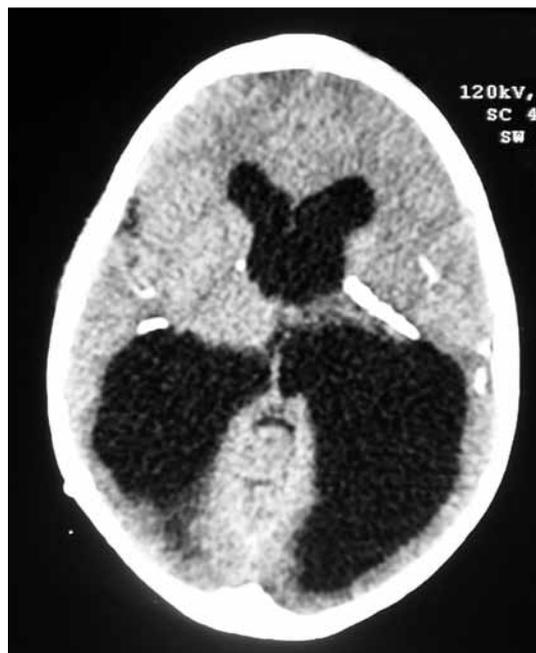
**Figure 2:** CT scan shows enlarged occipital horns of the lateral ventricles and calcifications in the brain.

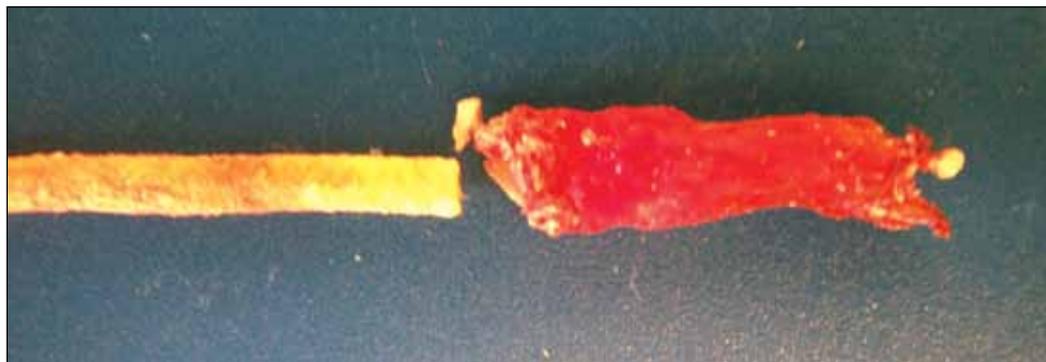
**Figure 3:** Macroscopic view of the calcified shunt tube and fibrocalcified tissue.

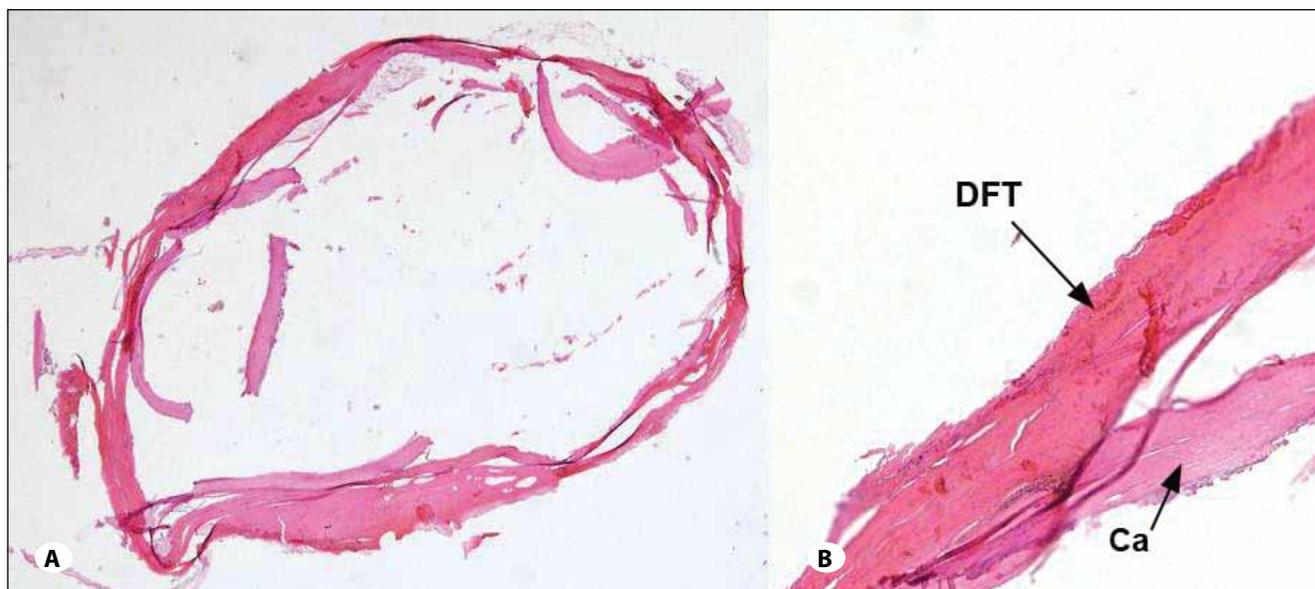
**Figure 4:** (A) Ring-like fibrocalcified zone is observed (H&E, x40); (B) Dense fibrotic tissue (DFT) forms the outer zone and calcification (Ca) forms the inner zone of the specimen (H&E, x400).

the rupture region. After an incision at the Frazier's point, the valve of the V/P shunt was found. It was also calcified and fixed to the cranium. After the removal of the ventricular catheter, the ventricles were controlled with a neuroendoscope, and choroid plexus calcification was observed. The new shunt was inserted through the same burr hole. The operation was terminated after verifying that the shunt was functioning well. Then, the peritoneal tip was inserted. Postoperative evaluation showed that blood calcium, phosphate, protein and pH values of the patient were within normal limits. CSF examination showed low levels of calcium and phosphate, and high levels of magnesium. Histopathologic examination of the specimens, which were obtained around the shunt tube, revealed dense fibrotic tissue in the outer zone and calcification in the inner zone (Figure 4A, B).

debris that accumulate in proximity to the implant has been demonstrated. This formation of initial nuclei is occasionally furthered by physical imperfections of the catheter (cracks, surface irregularities related to element extrusion secondary to material aging, and formation of silanol groups) and by cellular foreign body reaction, resulting in cell aggregation on the surface of the implant (1). In our patient, serum calcium and phosphate levels were in normal limits, but CSF examination showed low levels of calcium and phosphate, and high levels of magnesium. These results showed that calcification in our patient was a dystrophic type.
