Turk Neurosurg 28(3):483-489,2018

Original Investigation

Perioperative Technical Complications in Deep Brain Stimulation Surgeries

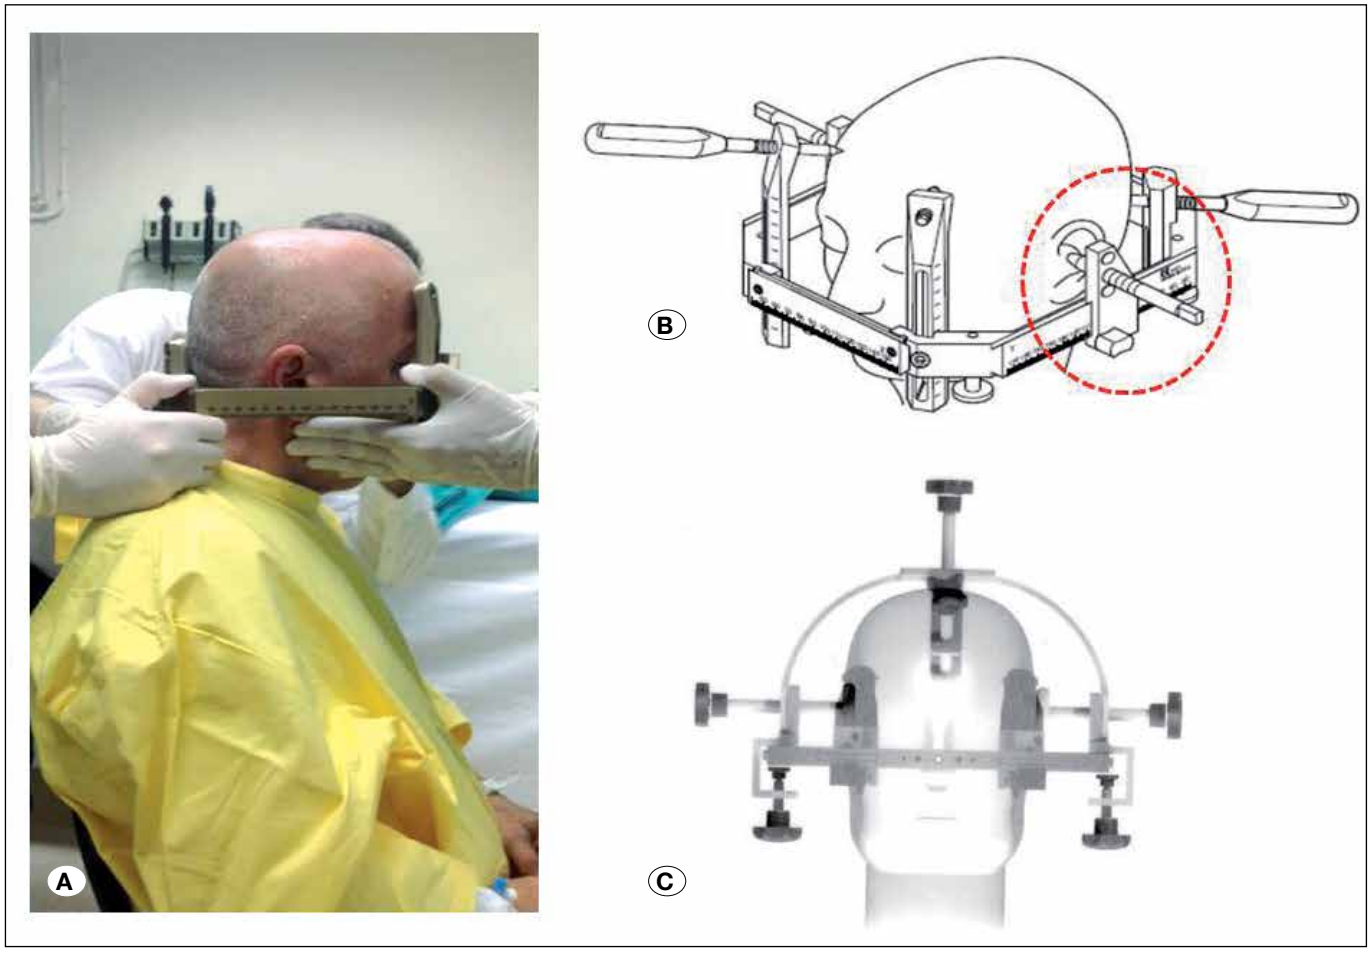
Movement-related Fixation Problems: Mounting the stereotactic frame in patients with severe hyperkinetic movement disorders is a well-known challenge (Figure 1A). There are methods which can be helpful in these cases. One method is to apply ear fixation (Elekta, Stockholm, Sweden) (Figure 1B). An ear plug fits into the holder through one of its three holes. The hole that yields the required frame height with respect to the skull is used. The highest frame position is achieved by inserting the plugs into the lowest holes. After applying the ear plugs, the screws are tightened with a screwdriver to fixate the system to the head of the patient in the desired position. However, a serious issue is that this procedure can be very painful and cause substantial discomfort. In animal studies, usually a local anesthetic is applied to the ear (13). Another and more recent method is the Stereotactic Position Aid device (Inomed, Emmendingen, Germany). The system enables the orientation of patient's head and frame before the frame screws are driven. This product can be used for the majority of the stereotactic frames and produces less discomfort as compared to ear fixation (Figure 1C). This complication has been seen in 7 out of 460 patients.

Figure 1: This figure shows the three methods of mounting the stereotactic frame on the head of the patient. **A)** The frame is fixated manually and mounted using the screws. **B)** An ear plug-assisted fixation method, **C)** A head-device supported fixation method is illustrated.

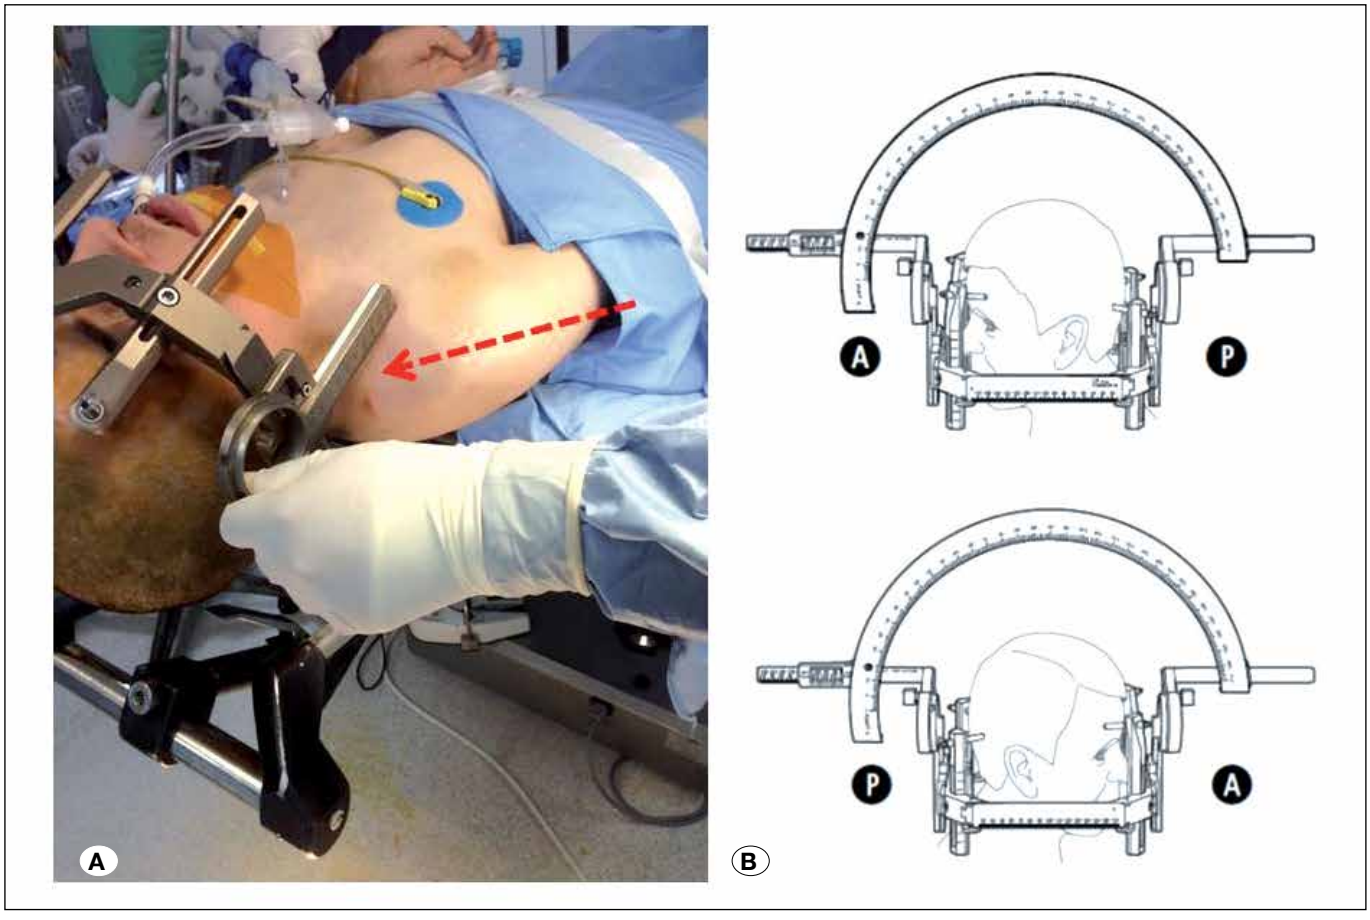
Head Anatomy Related Problems: Another problem can arise from the anatomy of the patient. The head anatomy is then not compatible with the shape of the frame. Especially the "arc support with slide parts" used in the Leksell Stereotactic G Frame and the Ark System (Elekta, Stockholm, Sweden) can be problematic in patients with a short-neck, even if the frame is placed as superiorly as possible (Figure 2A). These parts may apply serious physical pressure to the shoulder and may result in stopping the surgery. An alternative approach would be to change the orientation from "lateral right" or "lateral left" to "sagittal anterior" or "sagittal posterior" orientations (Figure 2B). We think that inspection of the neck length before frame fixation is an important action which is likely to avoid this complication. Another option to manage this complication is fixing the frame as inferior as possible on the patient's head. With this kind of inferior fixation, the parts which put pressure on the shoulder will show lower Z coordinate values. The parts causing pressure on the shoulder will also stay away from the skin. In 1 patient of our series we have experienced this complication.

Figure 2: A) The complication occurring with the Leksell G frame's slide parts in a patient with dystonia with a short neck is illustrated. The red dashed arrow points towards this anatomical obstacle. **B)** Solution to this problem by using a sagittal approach instead of a lateral one is shown.

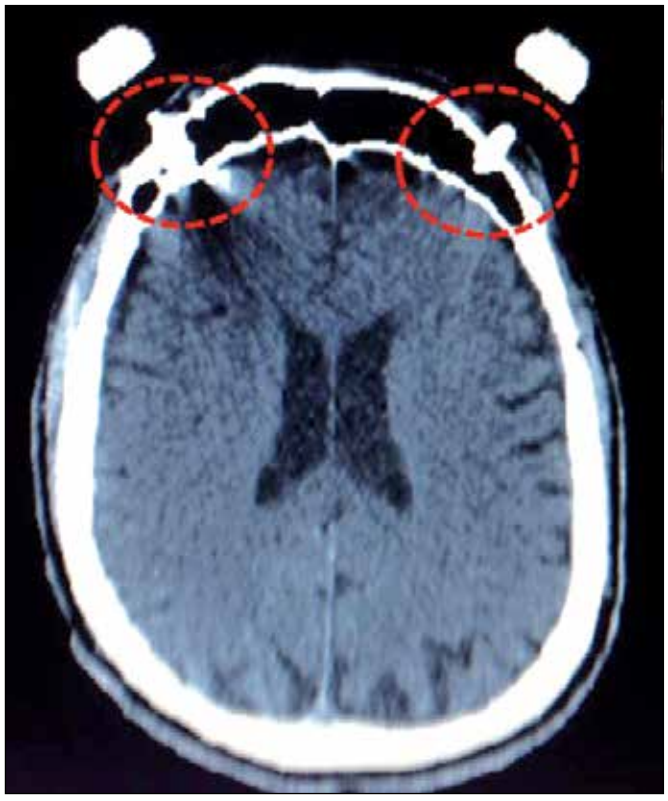
Another head anatomy related problem can be related to the frontal sinuses. Therefore, the anatomy of the frontal sinuses should be evaluated carefully before driving the frontal screws. If the screws are positioned slightly more superiorly in patients with a large frontal sinus, the outer layer can be fractured (Figure 3). This is a complication which may require surgical repair of the frontal sinus. This complication has been observed in 1 case.

Figure 3: Here, the frontal screws have penetrated the outer layer of the frontal sinus due to the combination of a superior placement of the screws and a large frontal sinus.

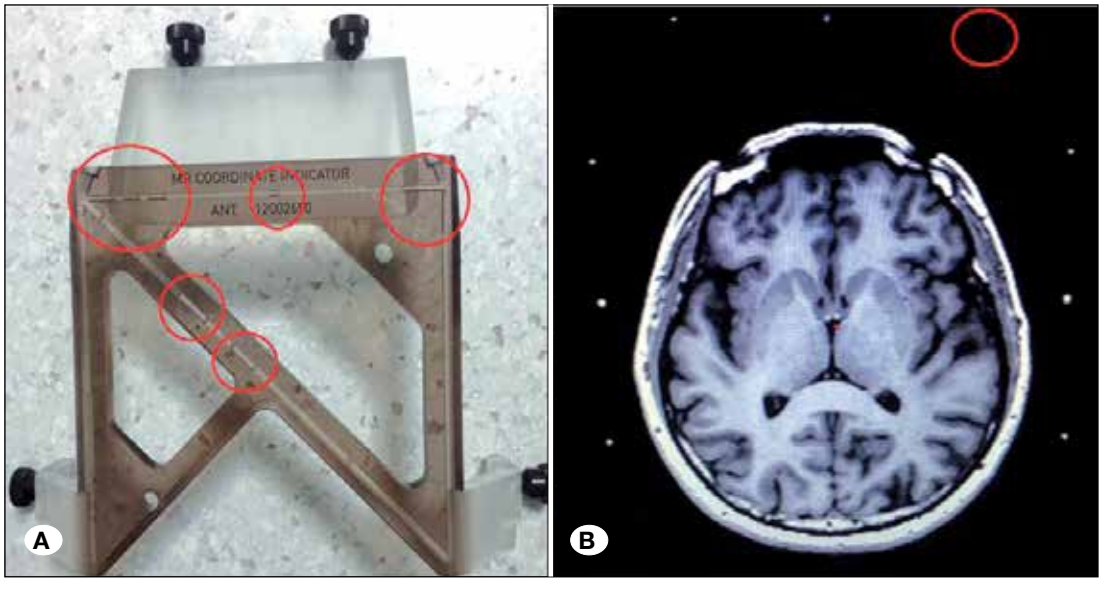
Air Bubbles in Localizers Using Liquid Solutions: In order to ensure fiducial marks are clearly noticed on MRI images, copper sulfate solution is recommended and used by some frame manufacturers. To obtain stereotactic MRI images for these systems, the localizer has to be filled with this solution. If the filling process is performed in an inadequate manner, air bubbles can remain in the copper sulfate solution filling localizer channels (Figure 4A). Performing the imaging with air bubbles will result in poorly detectable fiducial marks (Figure 4B). In this case, if MRI is preferred for stereotactic imaging, filling the localizer channels or checking the contents of pre-filled channels of localizer will be an effective way to prevent unwanted scenarios. This situation is not going to lead to any complications for the groups who are using CT localizers for stereotactic procedures. In 4 patients of our series, this complication was experienced.

Figure 4:
A) The anterior part of a localizer filled with copper-sulfate is shown. Red circles show the air bubbles in the channels of the localizer.
B) A stereotactic T1 MR image is shown. The invisible fiducial is indicated with red circle on the radiological image.

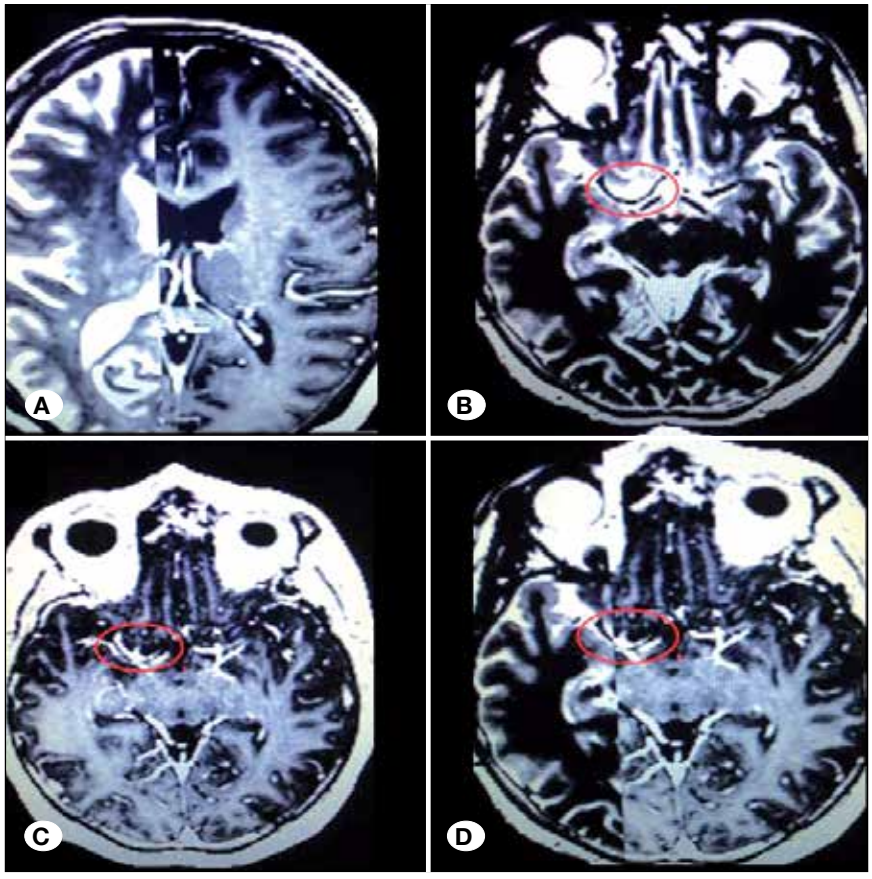
Cerebrospinal Fluid (CSF) Signal Effect Phenomenon on Image Fusion: One of the most important radiological image series used in the planning phase of DBS surgery is the axial T1 MR images with contrast enhancement to visualize vascular structures (1). The T2-weighed MR images are often used to directly visualize the target structures in DBS surgeries (9). Independent of the quality of the image fusion process performed for T1- and T2-weighed image series, the user may complain about the fusion quality of the images at the level of the lateral ventricles and the third ventricle. This perceived poor quality of fusion results from different signal characteristics of CSF in T2 and T1 images (11). CSF containing structures appear to have different volumes due to different signal responses of CSF to different sequences (Figure 5A). Such volumetric discrepancies noticed in the manual fusion quality checks may cause the user to perceive failed quality, even though the process has been completed successfully. At this point, we recommend using other anatomical structures instead of the ventricles to evaluate the quality of image fusion. Vascular structures, for instance, can be used for this purpose (Figure 5A-D). The pericranium is also a useful structure to evaluate the accuracy of image fusion. In 25 of 460 procedures, these volumetric discrepancies were experienced.

Figure 5: A) T1 and T2 axial slices merged at the level of lateral ventricles. CSF-containing structures have different volumes in T1 and T2 images. **B)** The red circle shows the blood flow signal in a T2 axial slice. **C)** The red circle shows the same vascular structure with a contrast agent in a T1 axial slice. **D)** The red circle shows the correlation between T1 and T2 images after the fusion process.

In the third and the last part, planning station related complications were described. The first complication mentioned was the image fusion failures because of the imaging angulation differences between different series to be merged. Performing all the imaging with respect to one standard plane is advised for that issue. Secondly, the CSF signal on different MR series resulting in unsatisfactory image fusion perception is described. Checking the image fusion quality through the vascular structures is advised as well.
